MAGGIO ESTATE DAM No. 2

NDI No. PA01120
PennDER No. 41-103
Dam Owner: Estate of Michael Maggio

PHASE I INSPECTION REPORT NATIONAL DAM INSPECTION PROGRAM

Maggio Estate Dam No. 2, Lycoming County, Pennsylvania
NDI No. PA 01120, PennDER No. 41-103
Red Run
Inspected 31 March 1981

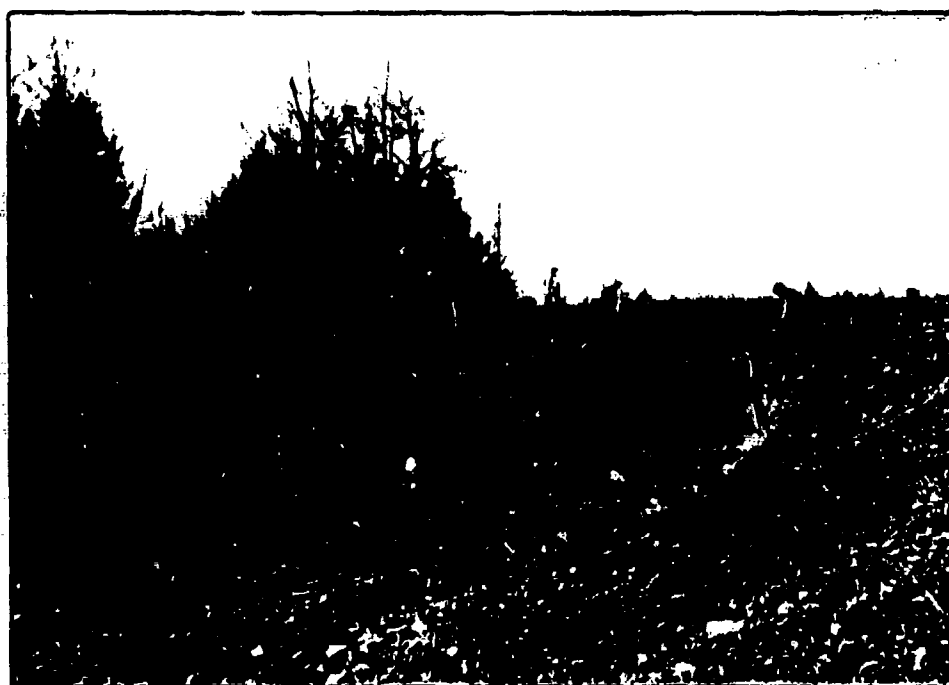
- c. Appurtenant Structures - The sides of the spillway are earth with no erosion protection. The downstream edge and sides of the concrete spillway are eroded and undermined. A clear seep of approximately 5 g.p.m. was observed at the downstream end of the concrete spillway. The earth discharge channel has very little erosion protection. Debris is collecting near the entrance of the 12-inch concrete outlet pipe.

PHOTO 1. View of Downstream Side of Spillway
